# Situation Photo Log

Monday, February 4, 2013

Kalamazoo River / Enbridge Spill

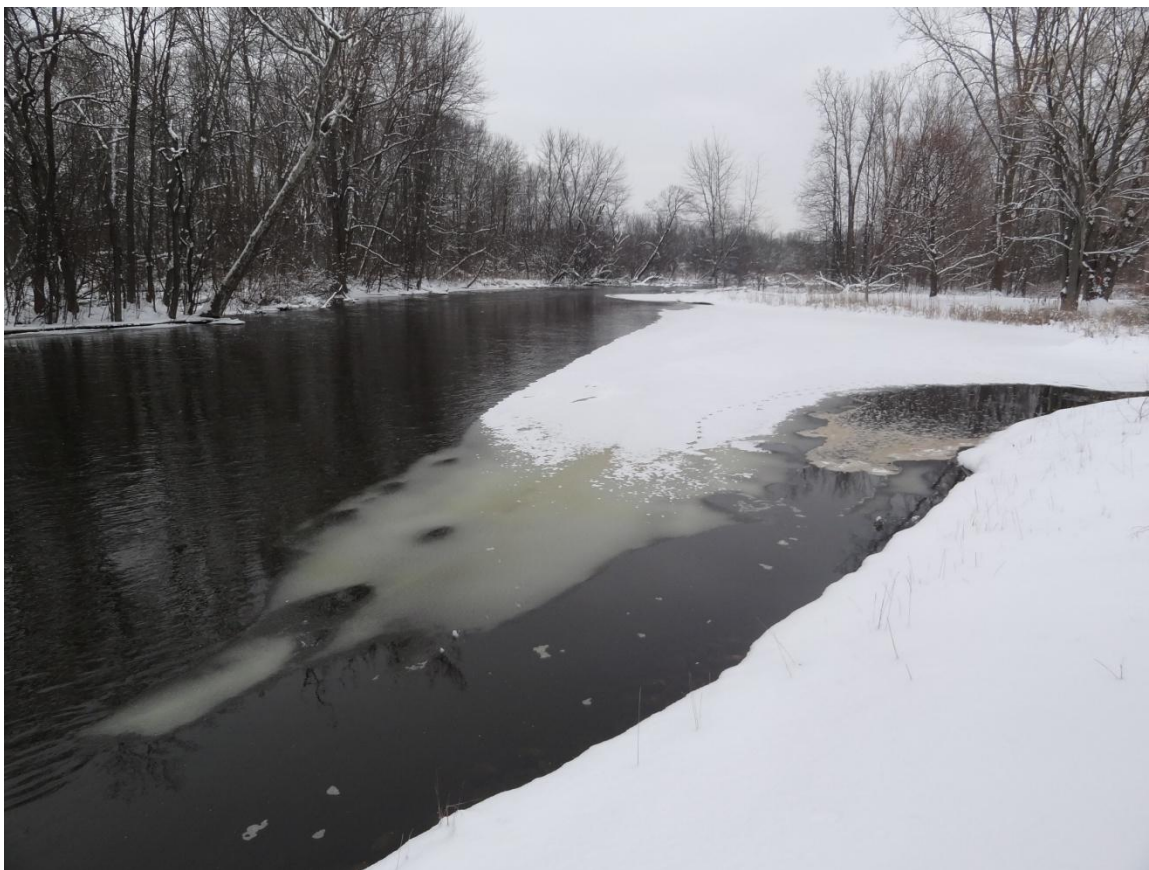
**1. Confluence observed icing conditions.**

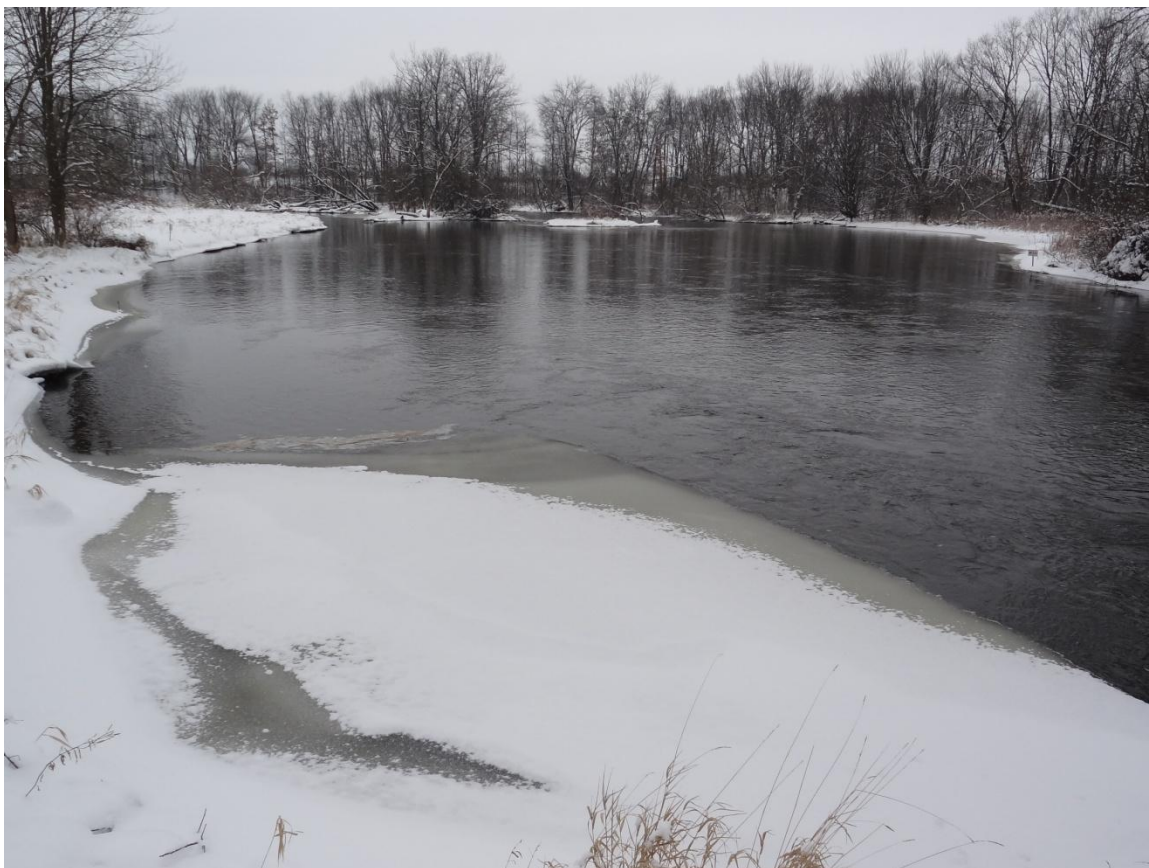
**2. MP2.25 observed river icing conditions.**

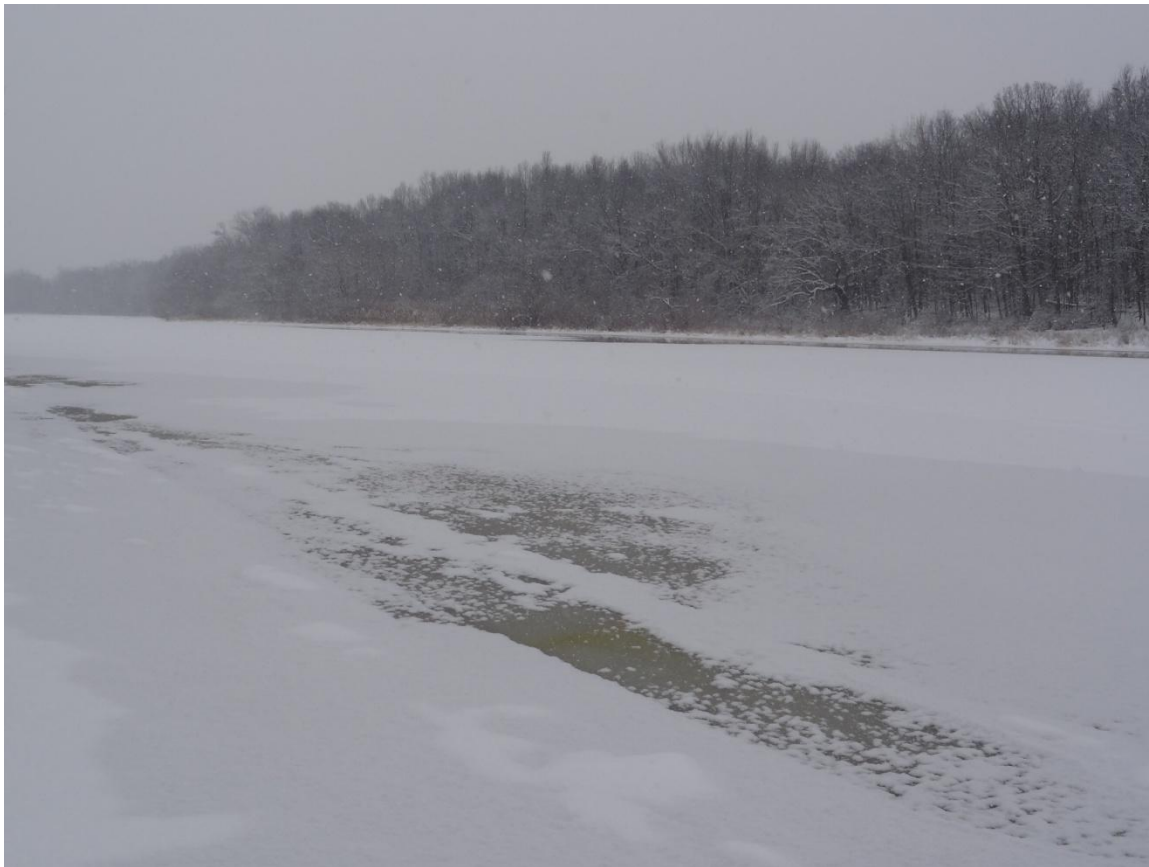
3. C0.4 Boat Launch observed upstream river icing conditions.

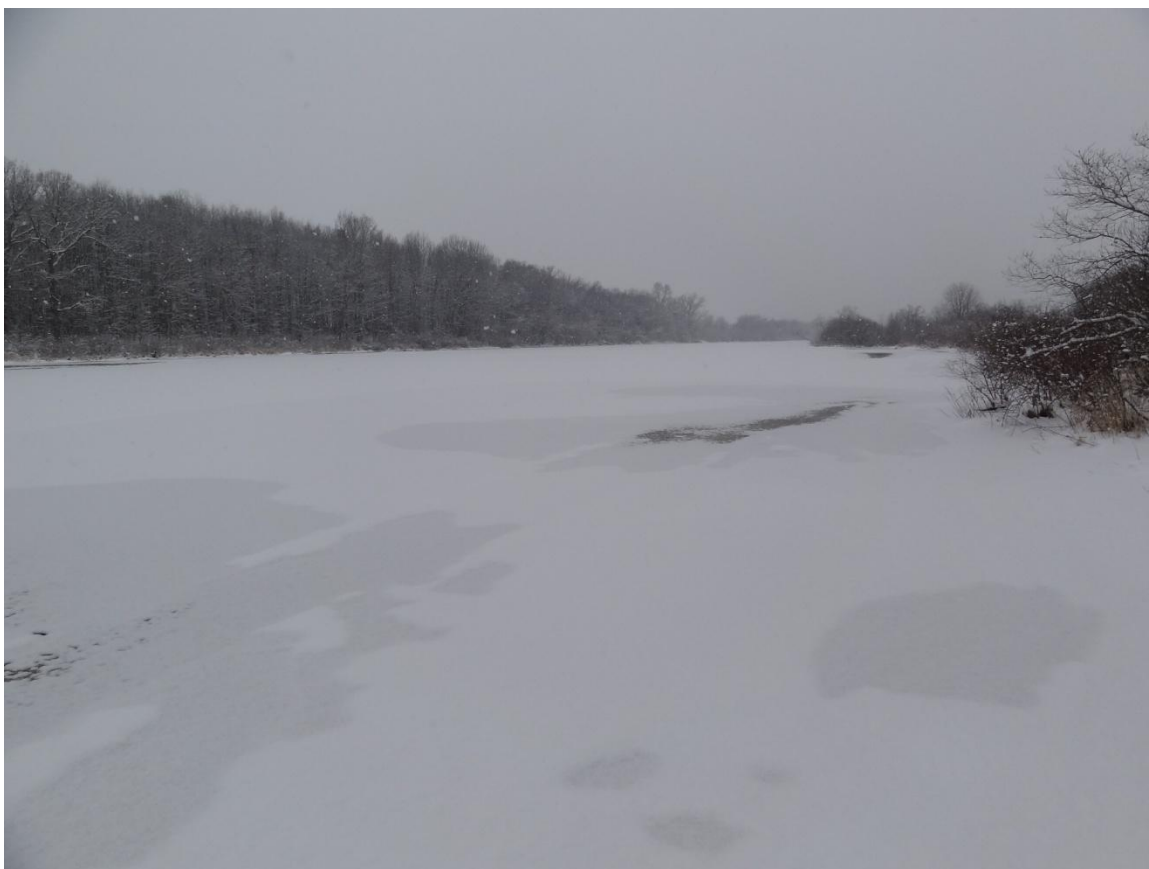
4. C0.4 Boat Launch observed downstream river icing conditions.

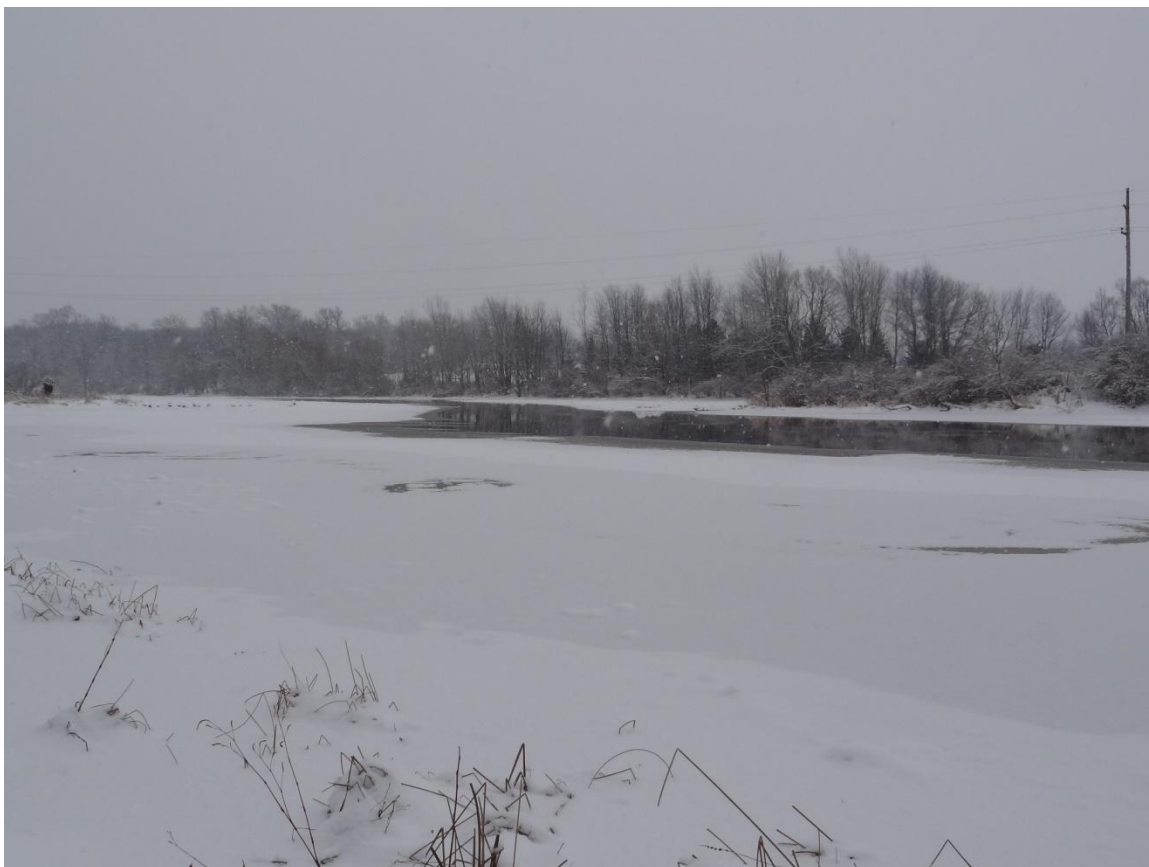
**5. Ceresco Dam impoundment observed upstream river icing conditions.**

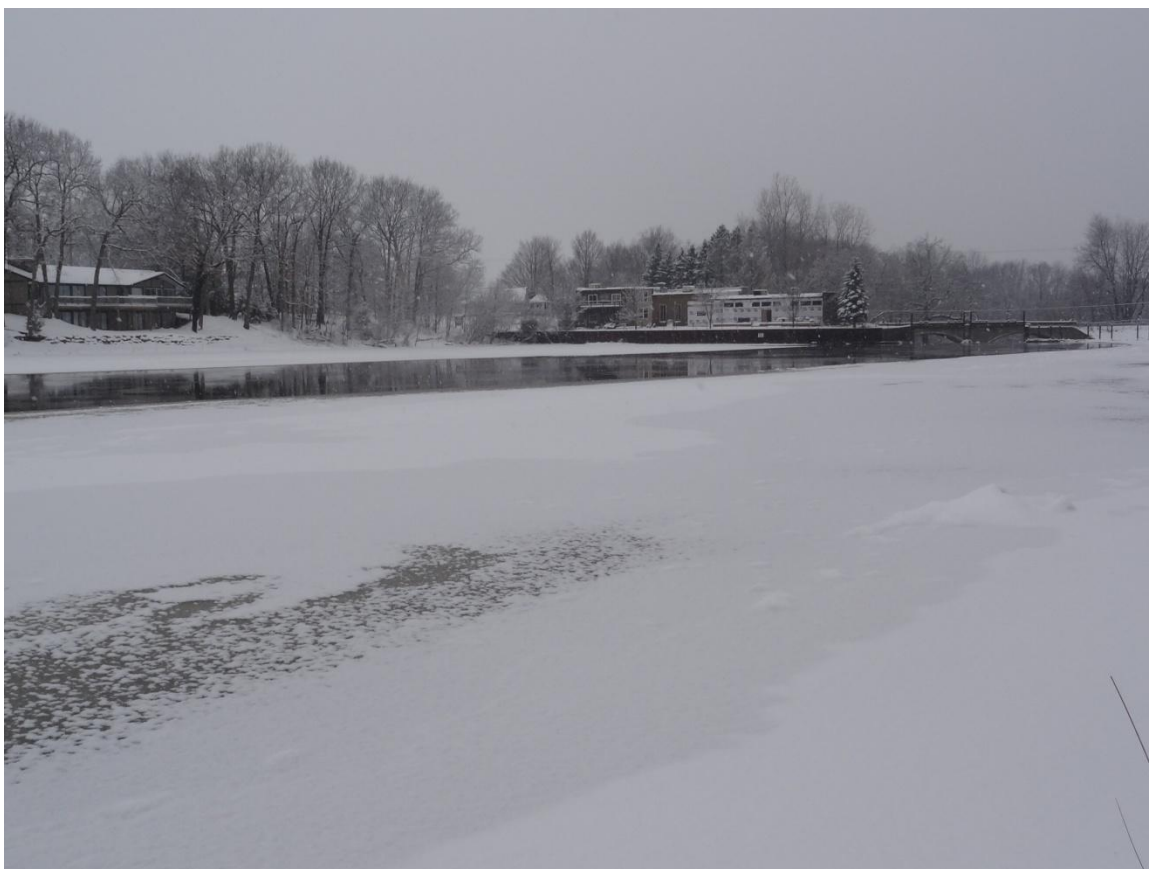
**6. Ceresco Dam impoundment observed downstream river icing conditions.**

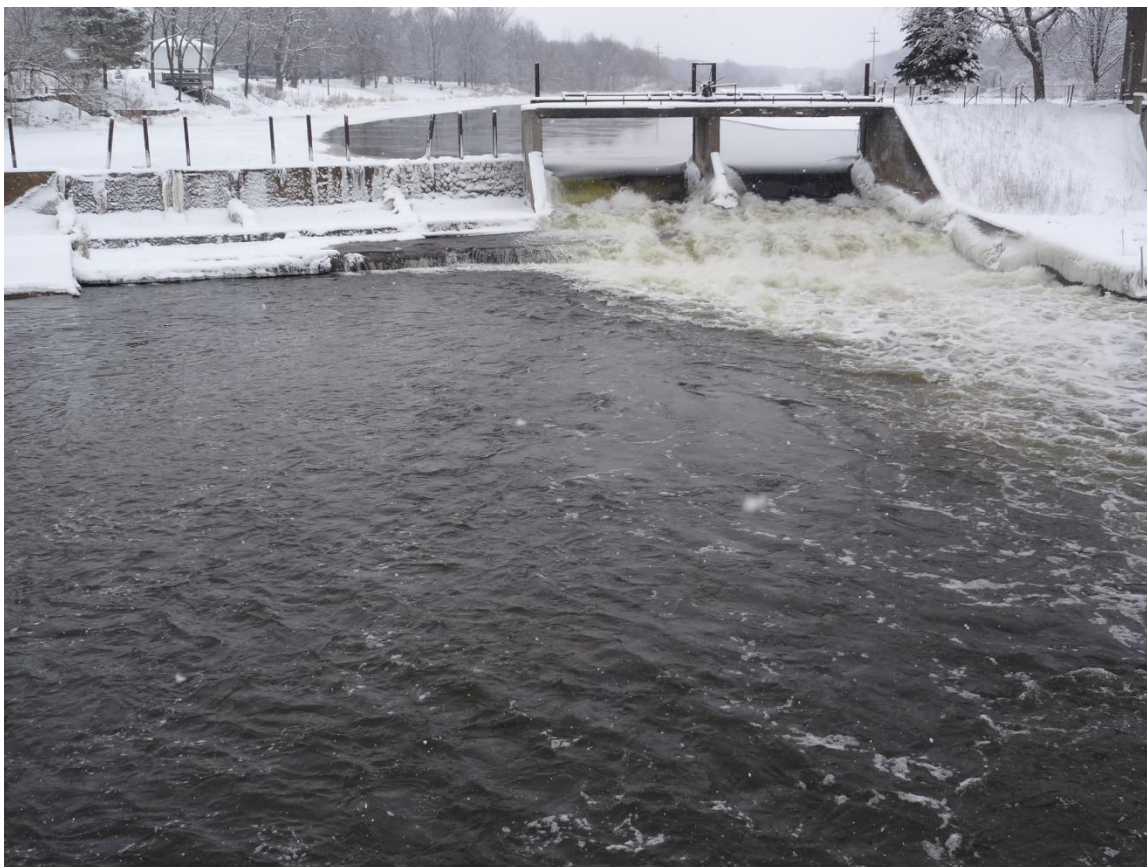
7. Ceresco Dam observed icing conditions.

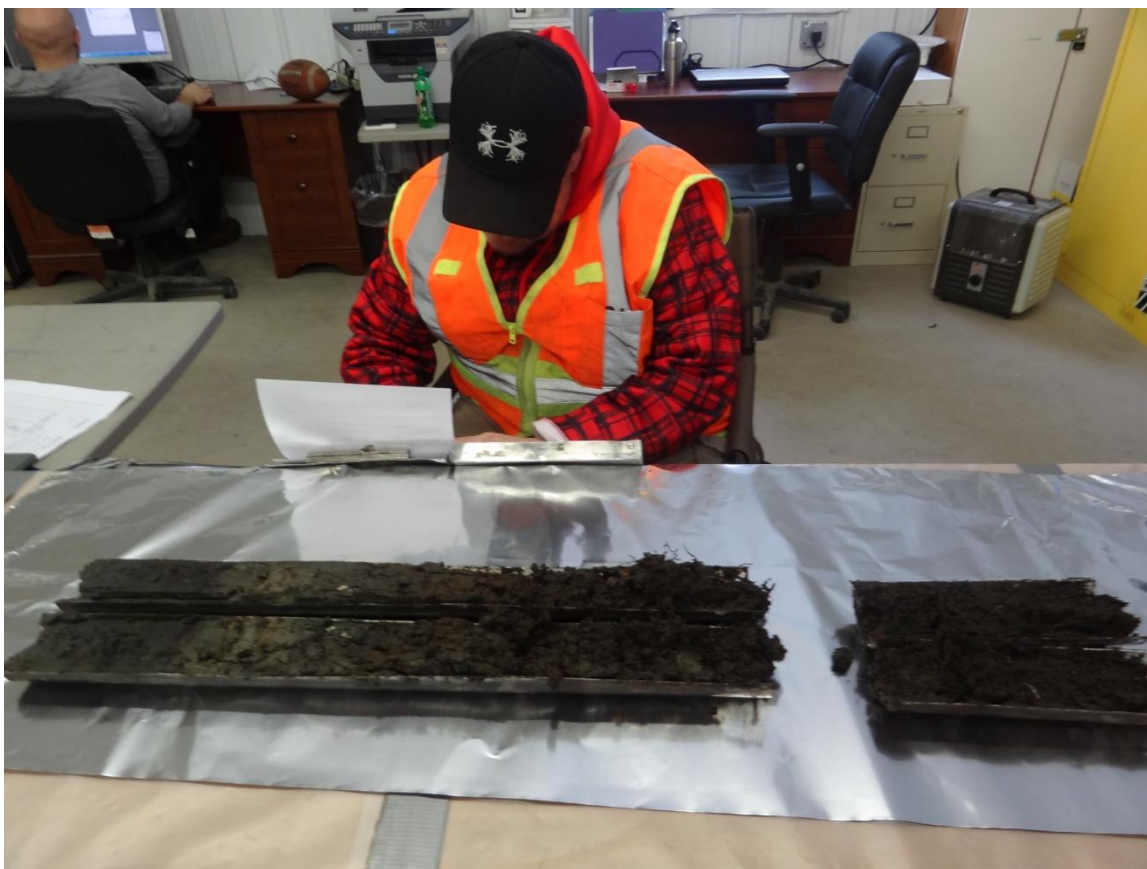
8. C3.2 Pole Barn observed core logging procedures.

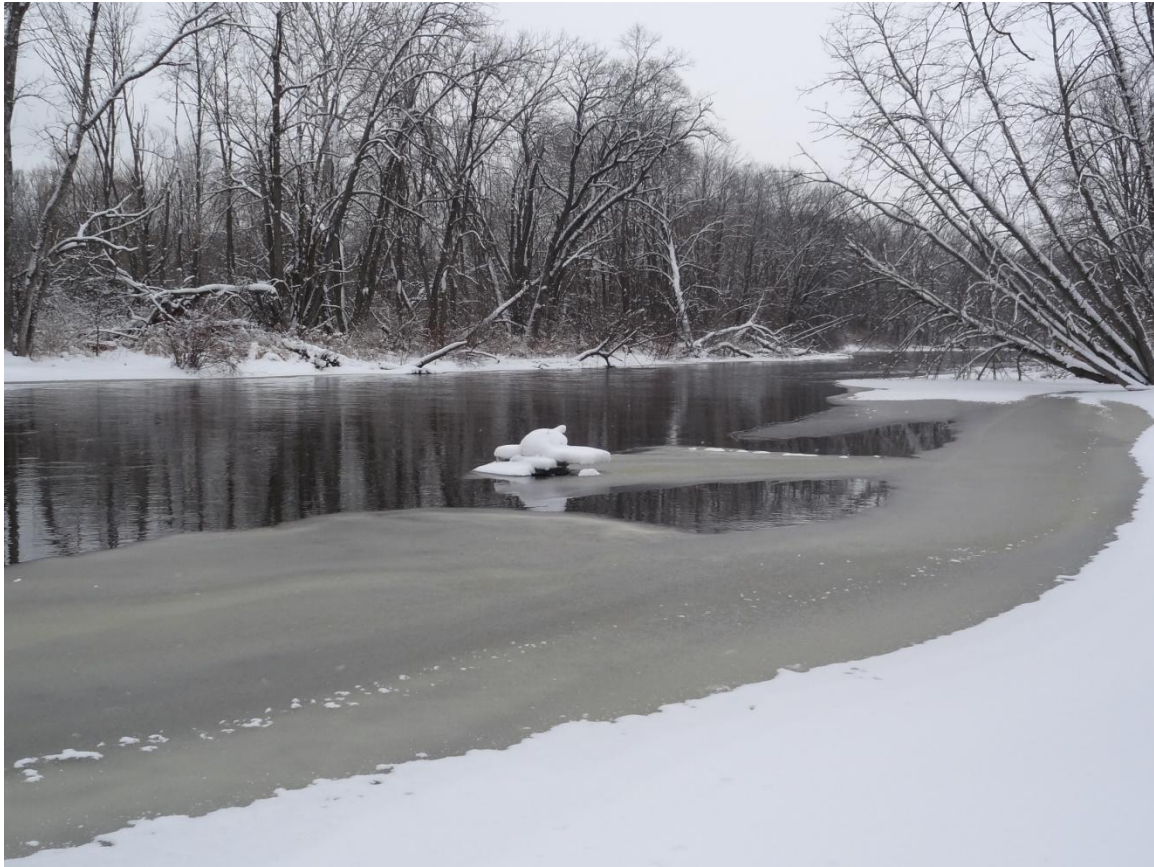
**9. C3.2 Boat Launch observed upstream river icing conditions.**

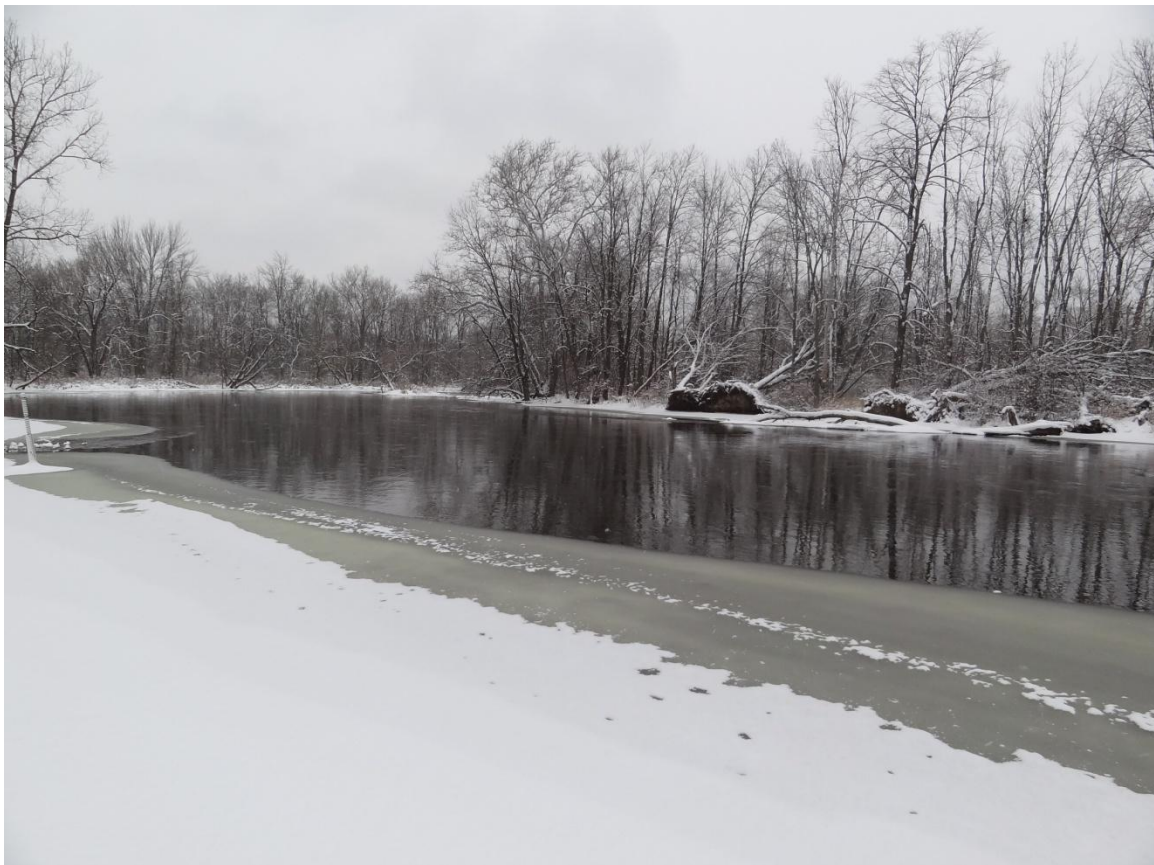
**10. C3.2 Boat Launch observed downstream river icing conditions.**

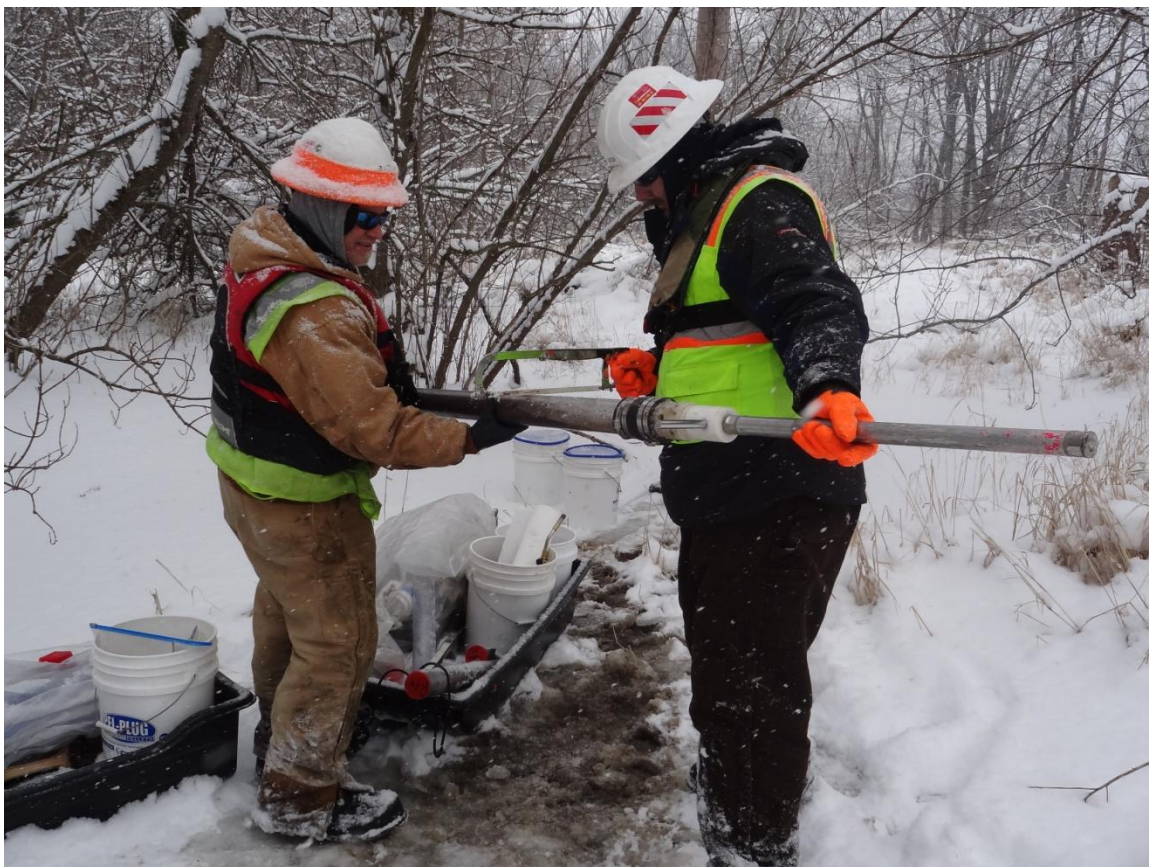
11. MP13.50 RDB observed the RI team.

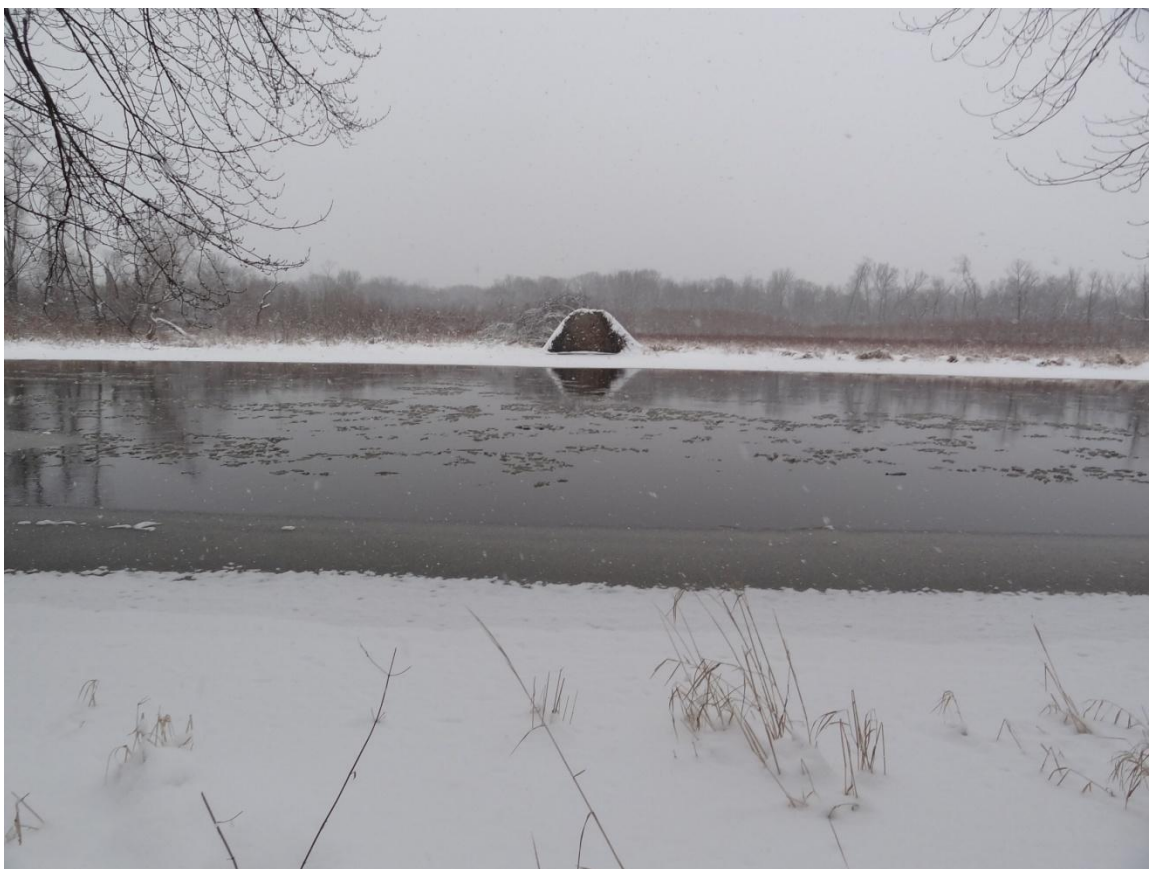
12. MP13.50 observed river icing conditions.

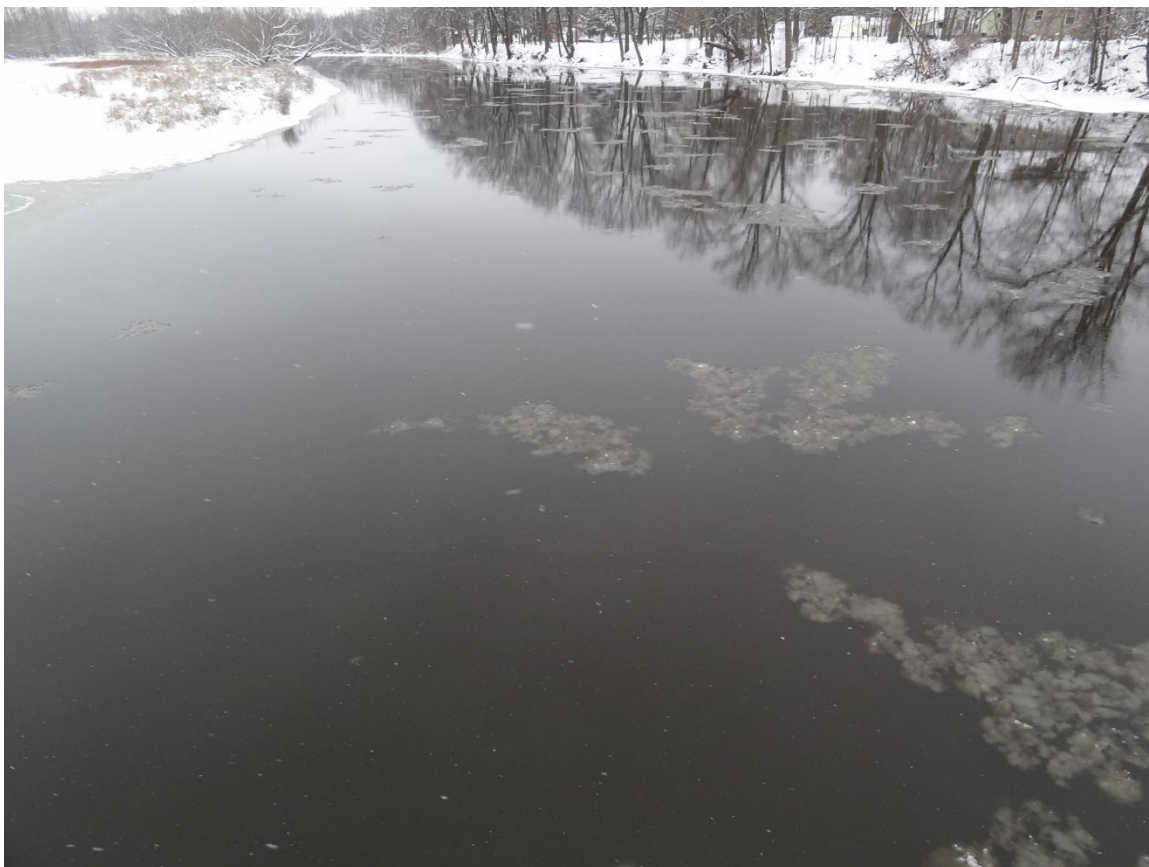
**13. MP15.25 South Mill Pond observed river icing conditions.**

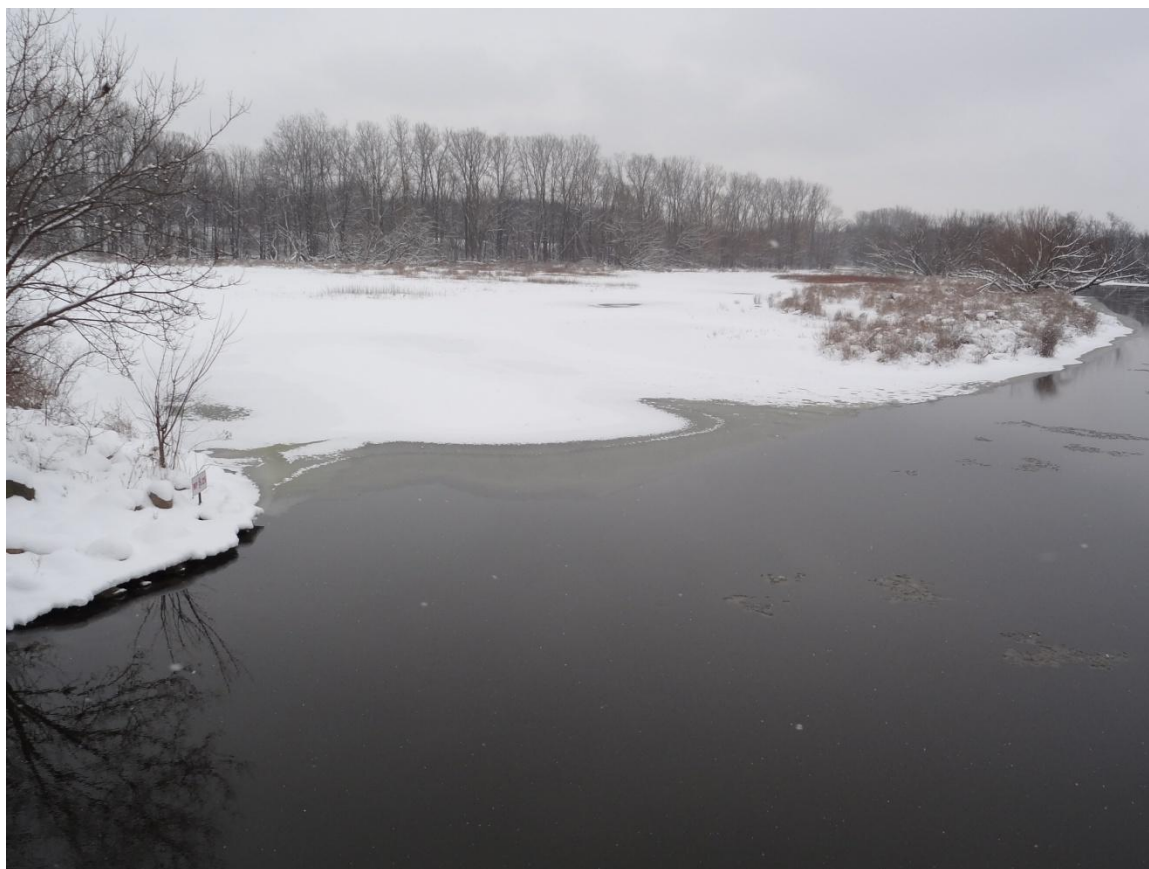
**14. MP15.25 South Mill Pond observed back water icing conditions.**

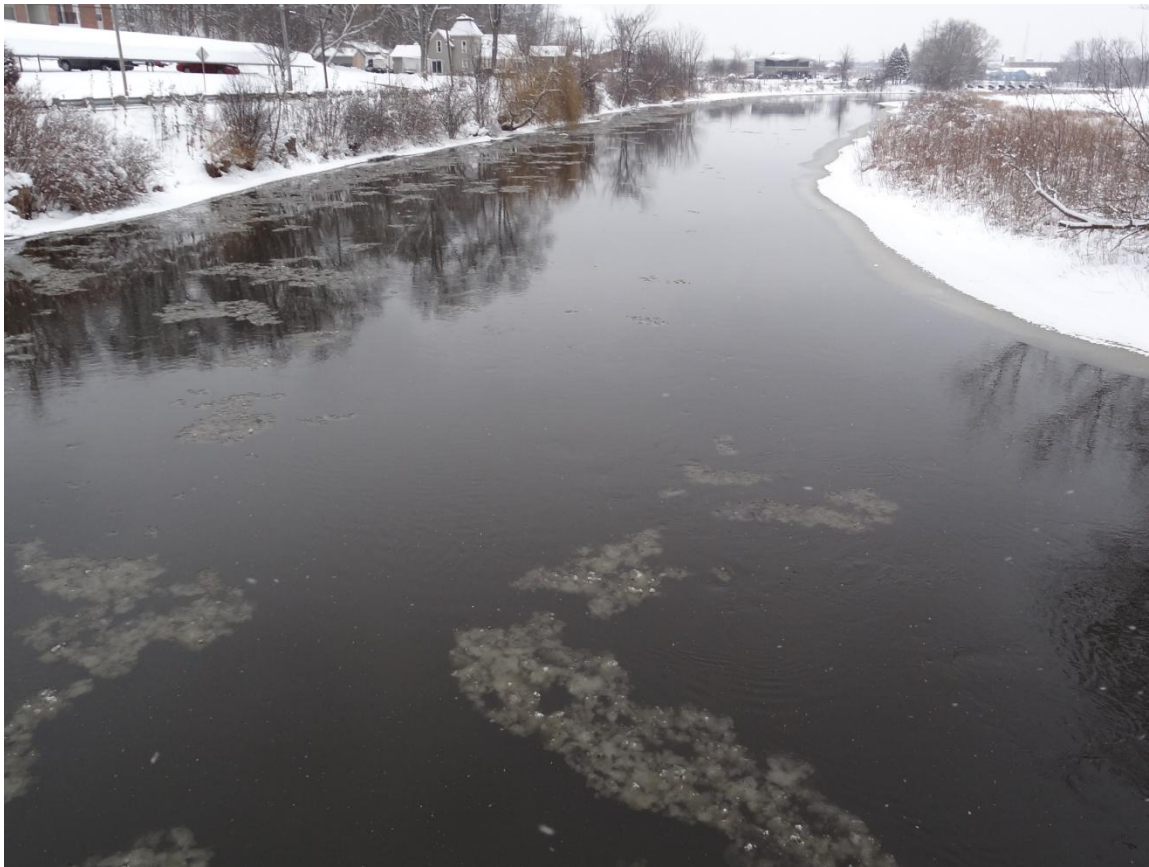
15. MP15.50 North Mill Pond observed river icing conditions.

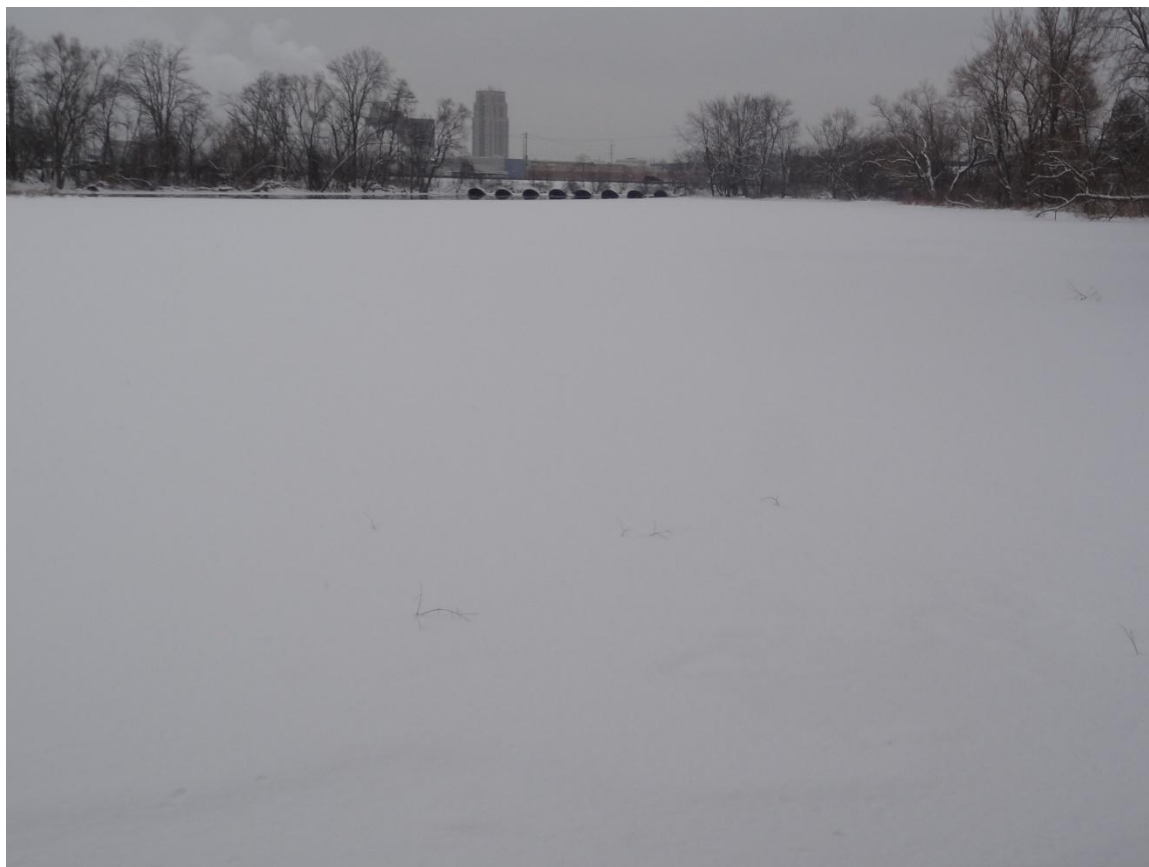
16. MP15.50 North Mill Pond observed back water icing conditions.

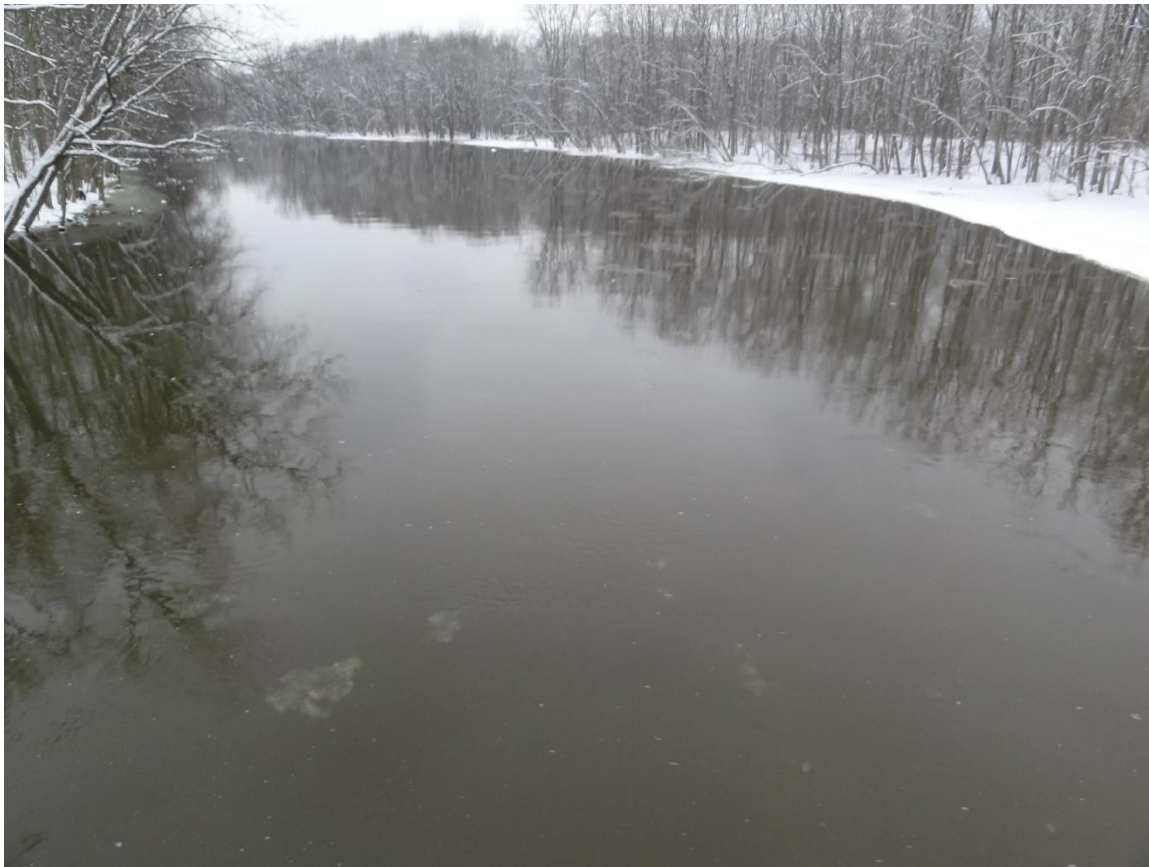
17. MP21.50 observed river icing conditions.

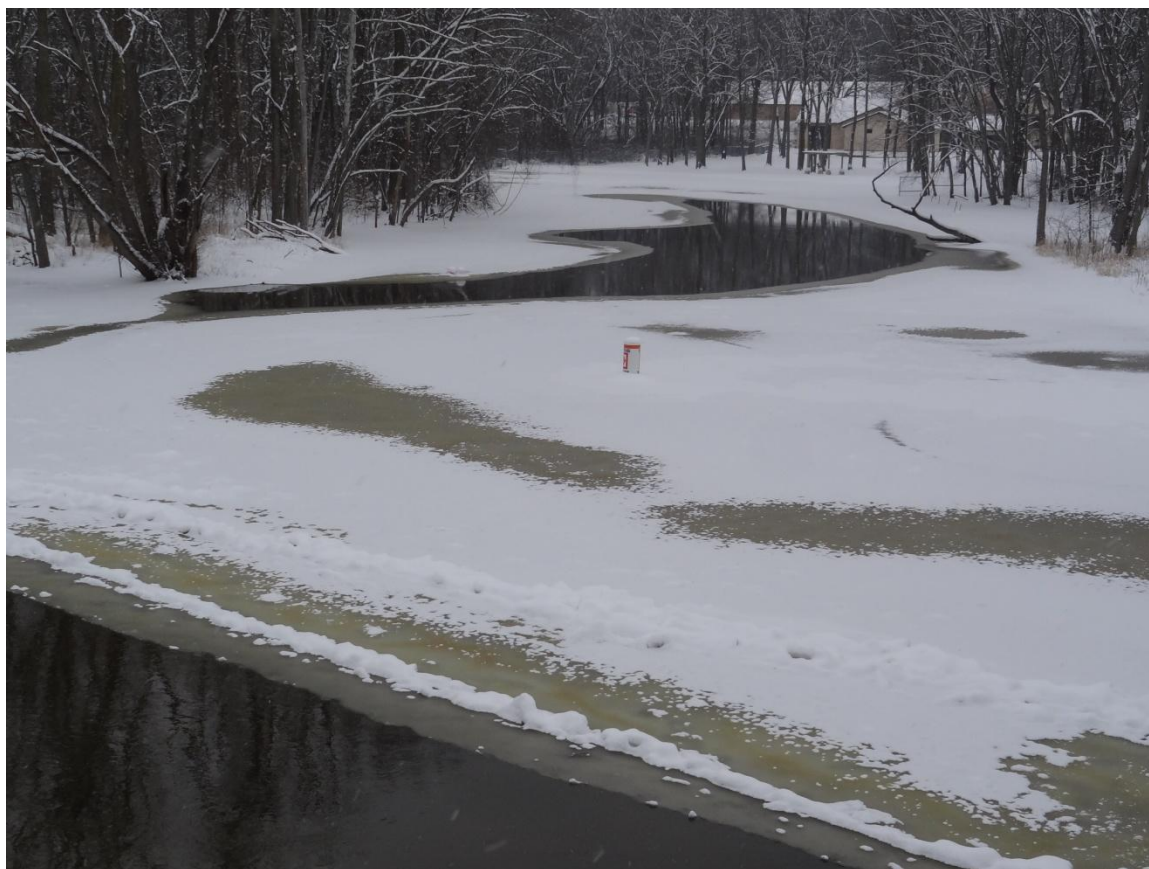
18. MP21.50 Oxbow observed icing conditions.

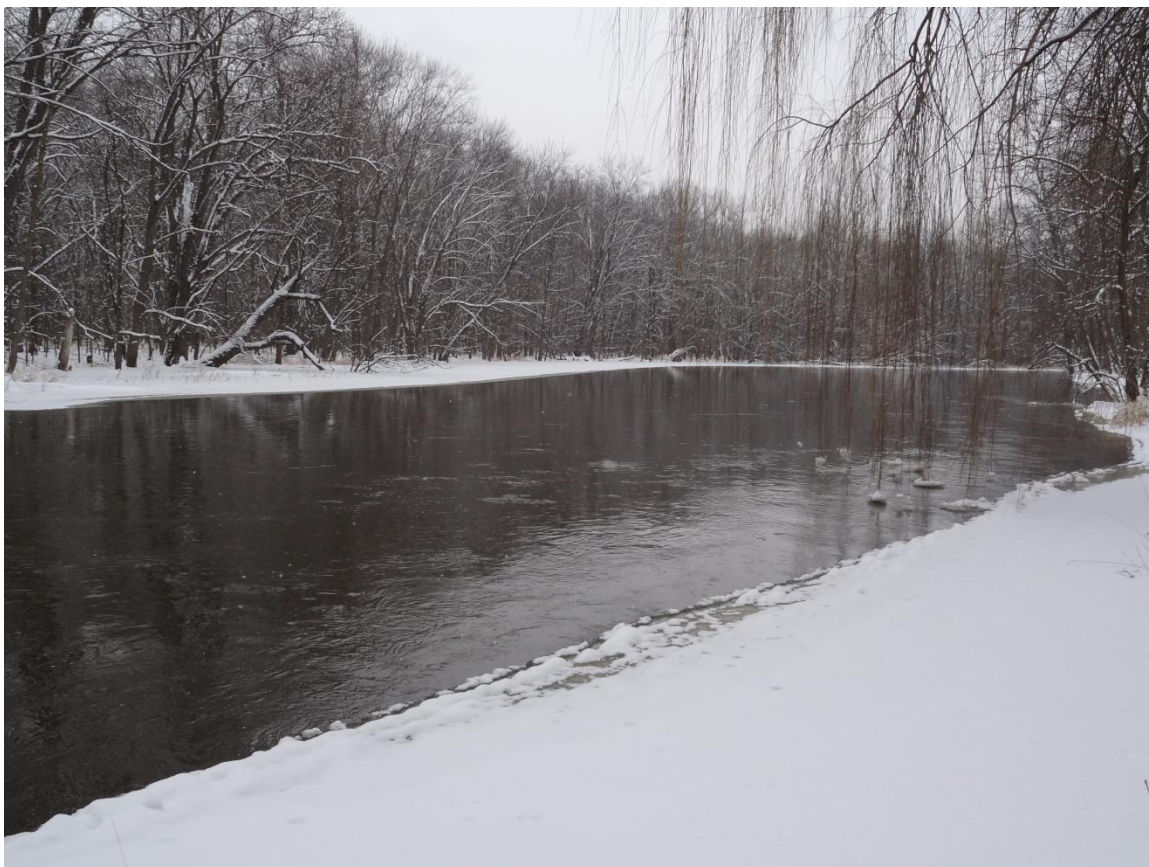
**19. MP27.00 Shady Bend Campground observed river icing conditions.**

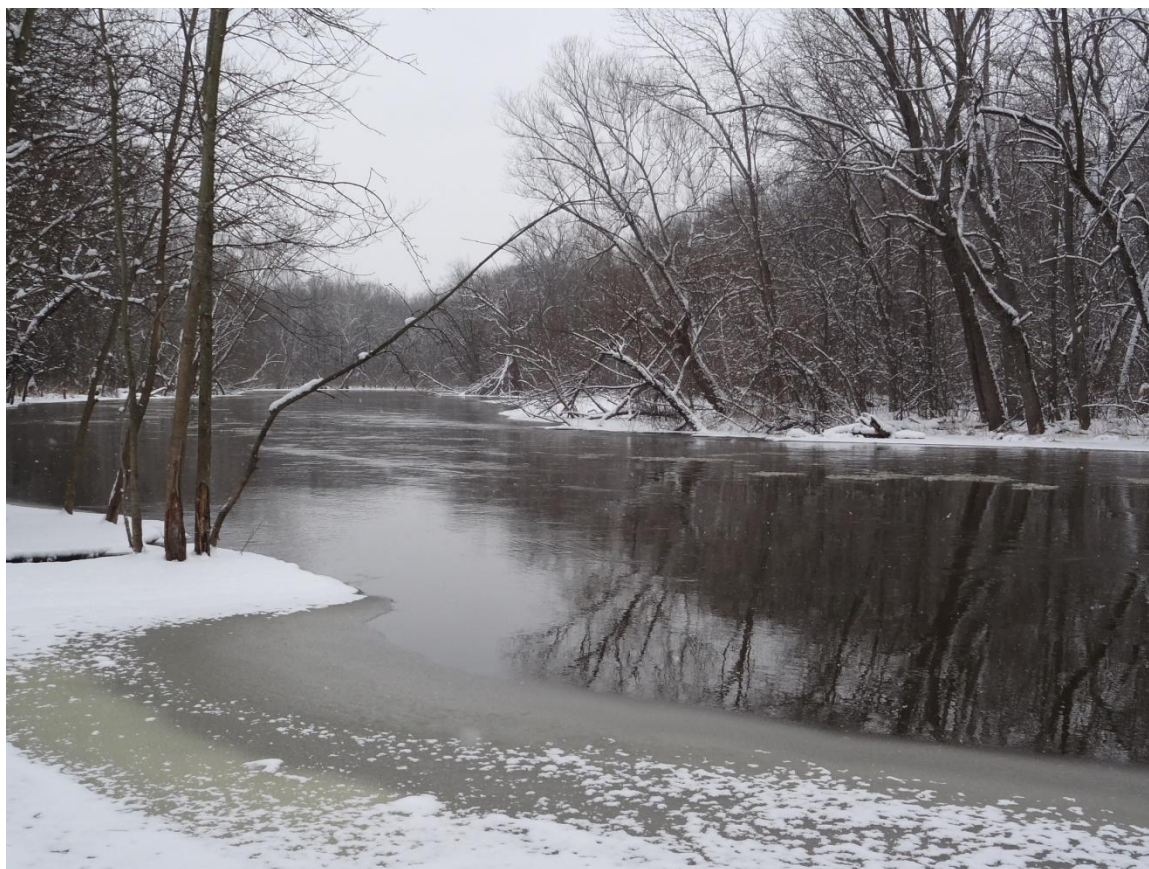
**20. E2 Boat Launch observed river icing conditions.**

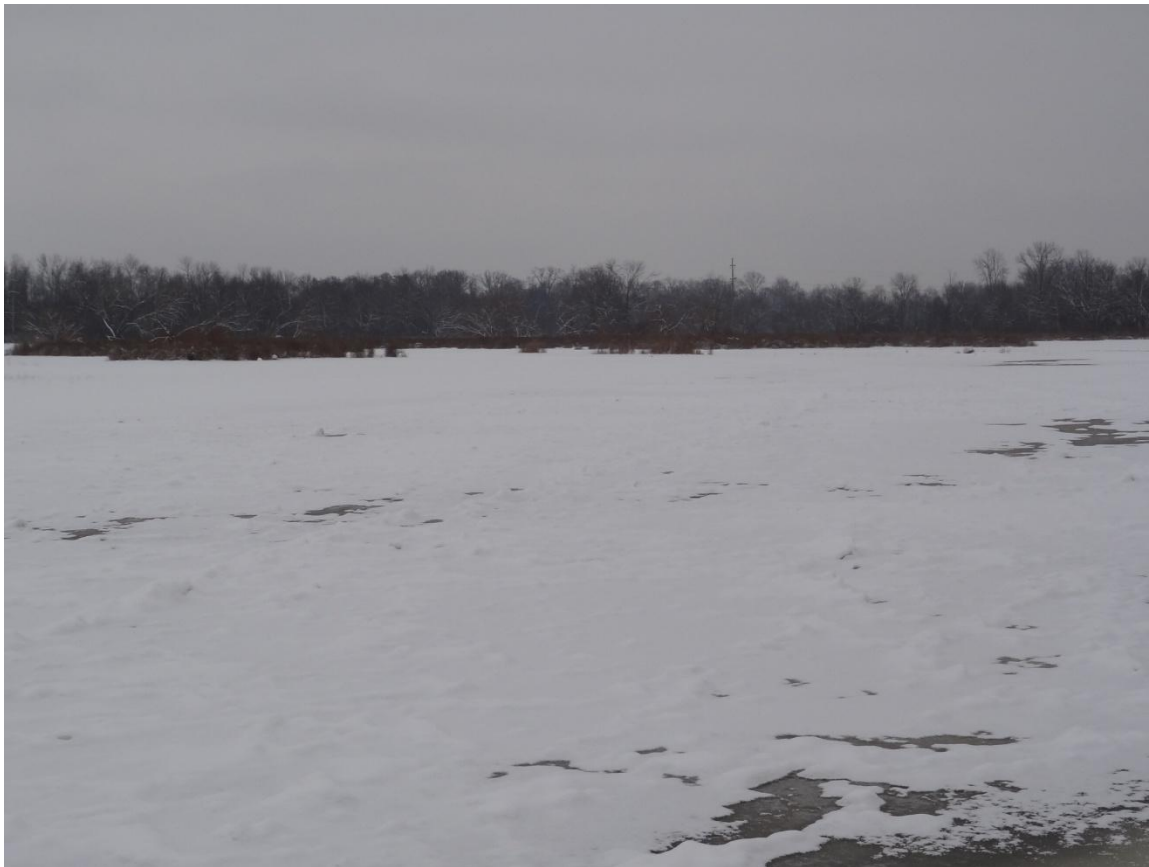
**21. Morrow Lake Delta observed icing conditions.**

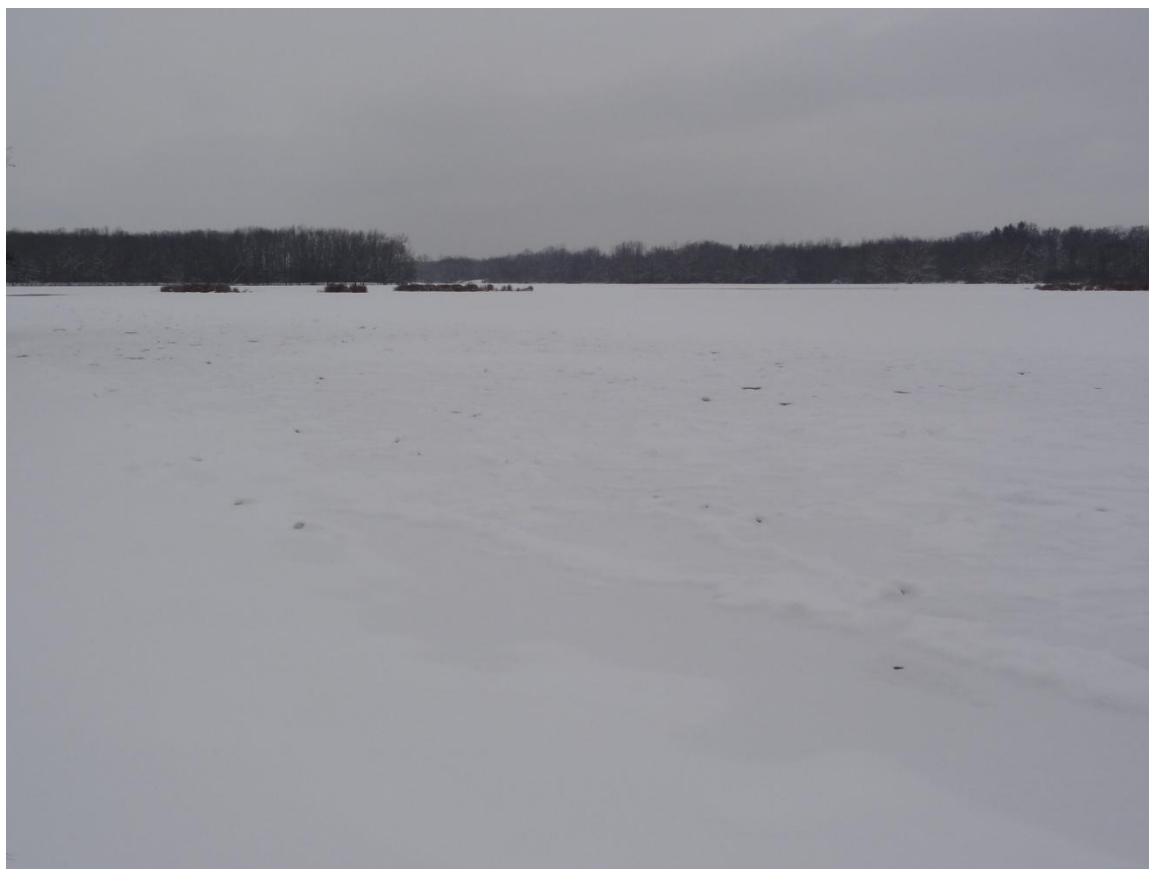
**22. Morrow Lake Delta observed icing conditions.**

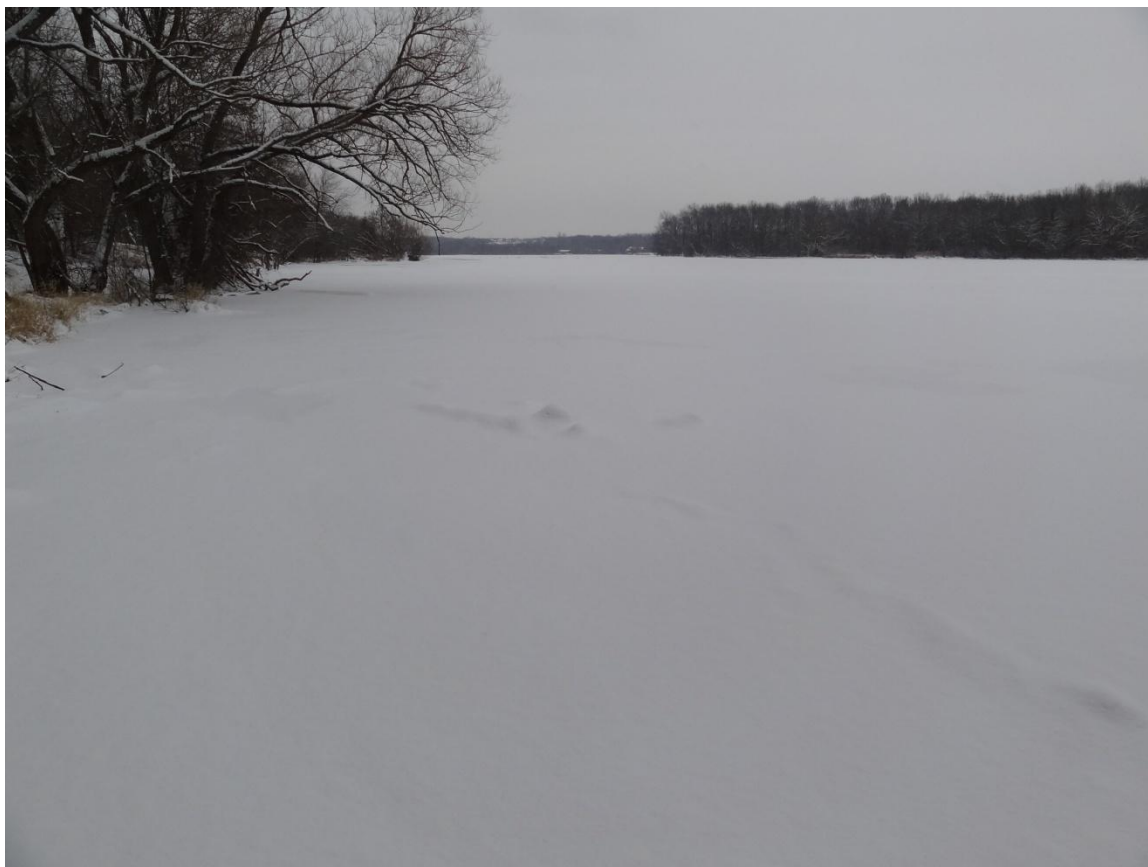
**23. Morrow Lake Neck/Morrow Lake Delta observed icing conditions.**
